TECHNICAL NOTE

U.S. DEPARTMENT OF THE INTERIOR – BUREAU OF LAND MANAGEMENT

VINCENT CREEK FISH PASS

John W. Anderson, Fishery Biologist
Coos Bay District, Oregon

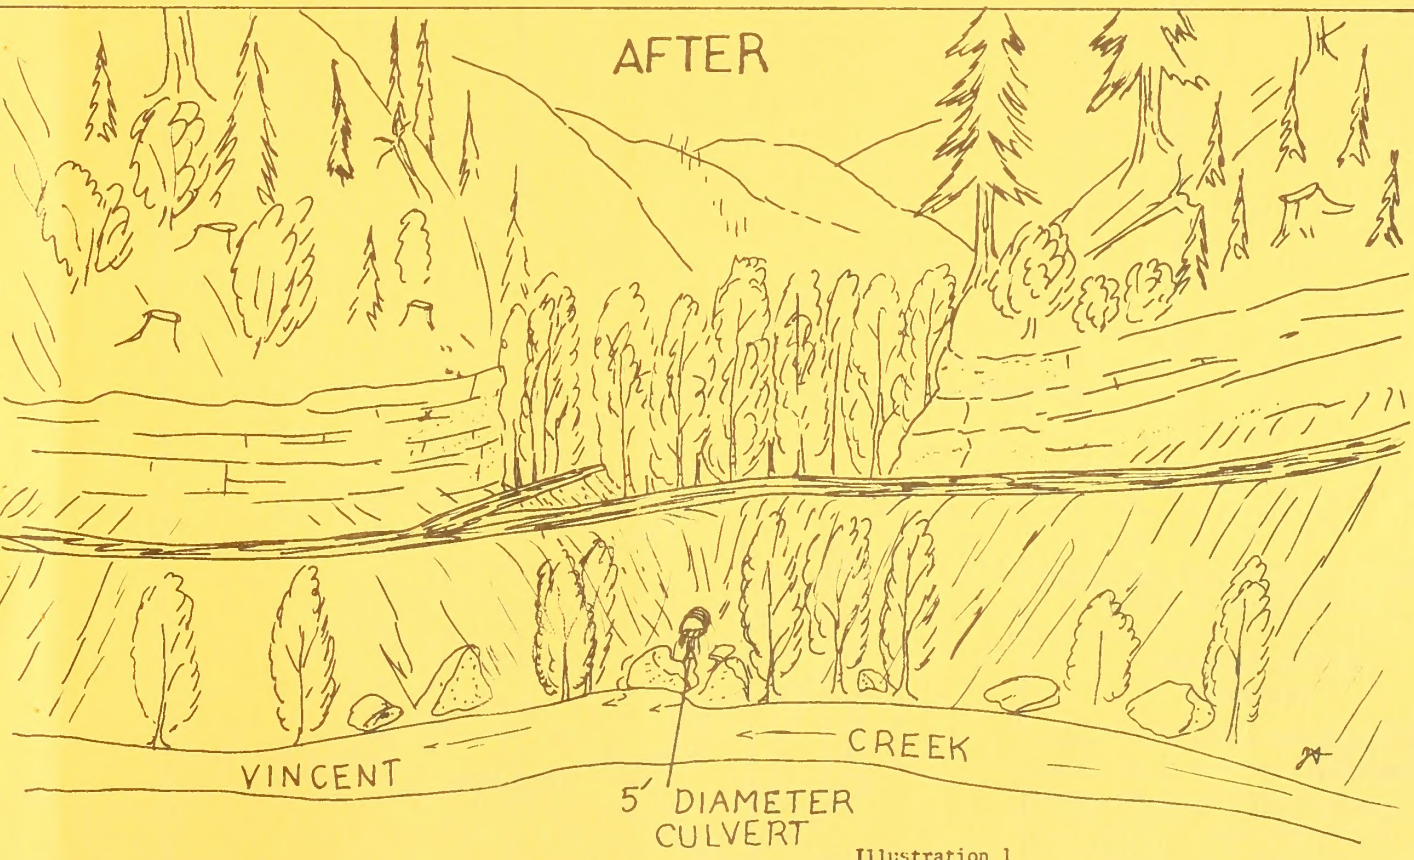
Illustration 1

Explorer 155 Creek before and after road construction

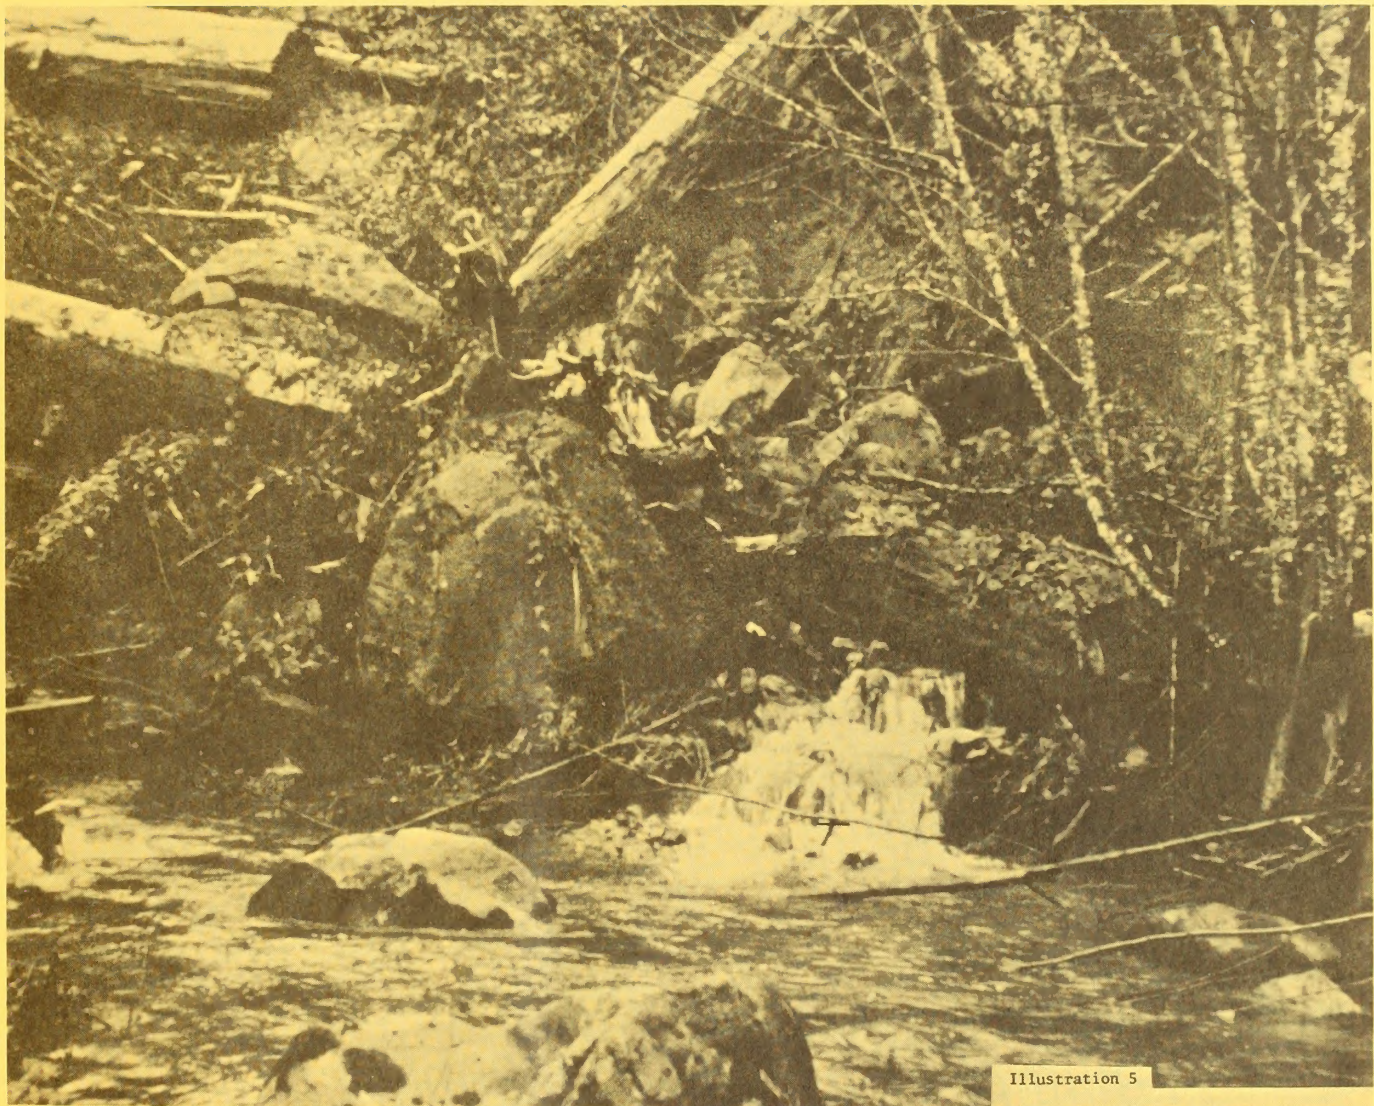
Illustration 5

A culvert installation on Explorer 155 Creek, a tributary of Vincent Creek in the Smith River basin, was identified as a total barrier to fish passage. The culvert was placed on top of a 7.5' high fill that was pushed into the stream at its confluence with Vincent Creek in 1958. The 5' diameter culvert was then covered with 24' of fill to establish an even road grade (Illustrations 1 and 5). The road is a mainline, hard surface road paralleling Vincent Creek. It was estimated that it would cost \$35,000 to remove the culvert and fill and replace it with a bridge. The gradient may have been too steep to provide fish passage even after such a major project was undertaken.

The mouth of Explorer 155 Creek before construction of fishpass and ladder box

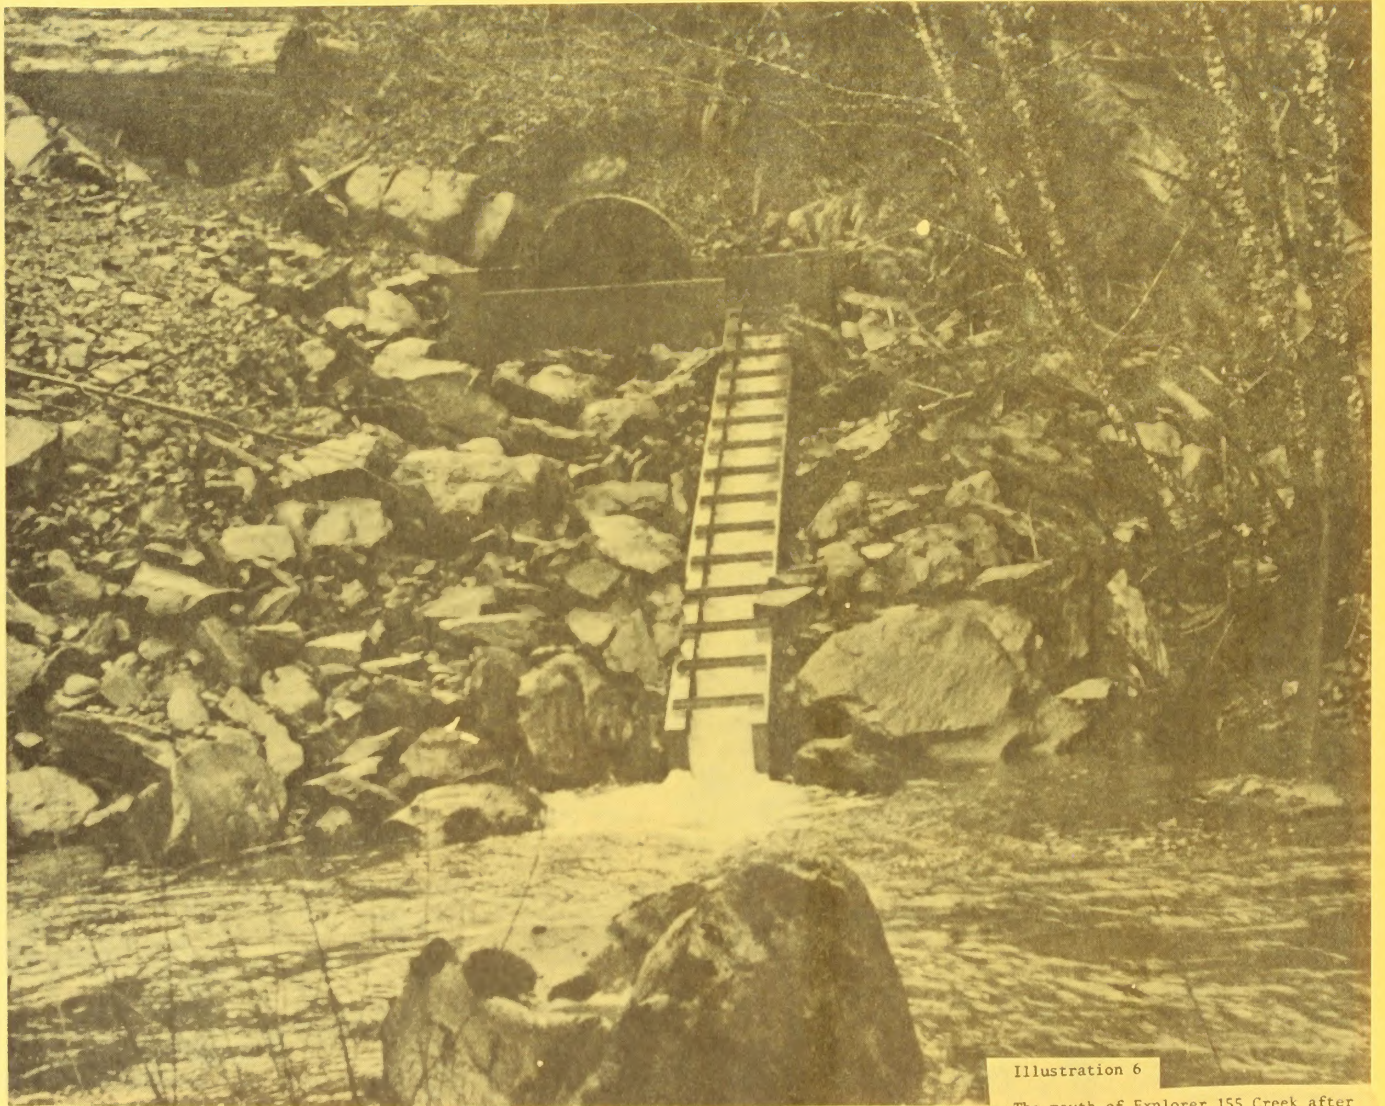
Illustration 6

The mouth of Explorer 155 Creek after installation of ladder box and fishpass

It was suggested by the District Fishery Biologist that a ladder box and modified Alaskan steeppass fish ladder be installed to bring fish up to the culvert mouth (Illustration 6). The culvert was nearly level which made it passable if fish could reach it.

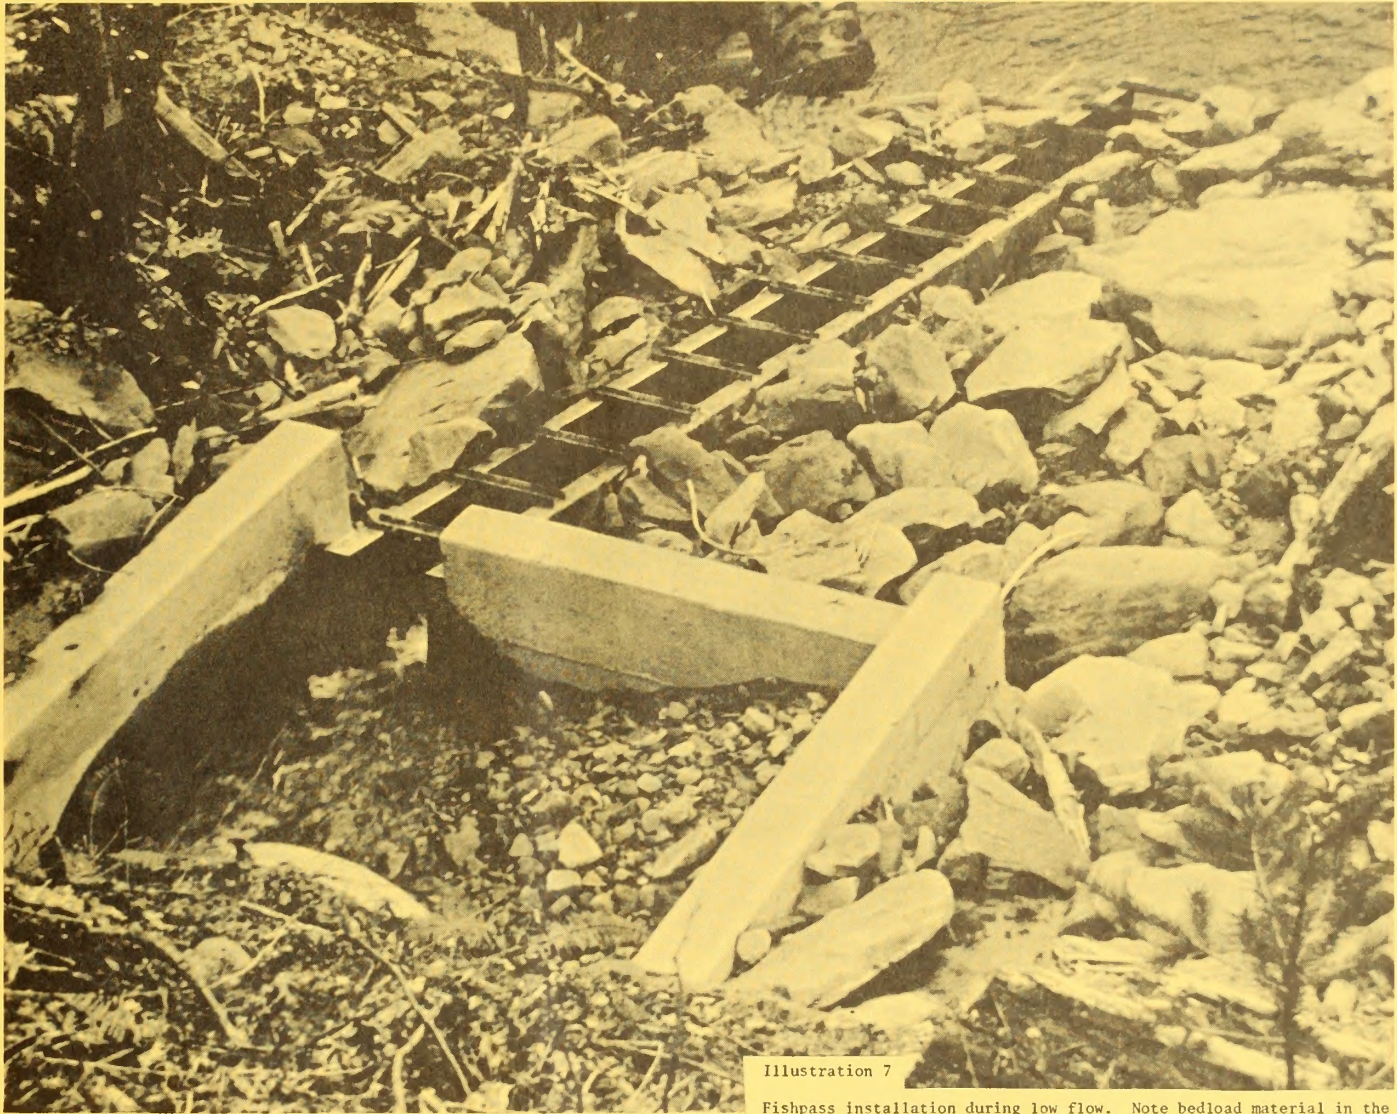
Illustration 7

The ladder box was designed to be large enough to provide a holding area for fish before they entered the culvert. The depth of the box was 5-feet. The stream bedload has filled the box level with the bottom of the steppass slot (Illustration 7). No pool area is apparent at low flow and only a shallow pool 30-inches deep is present at high flow. One spent coho male was observed maintaining his position for at least 30 minutes or more without apparent difficulty.

It would appear that the size of the box in length and width is quite adequate. The box has a depth of 2-feet 2½" below the steppass bottom. The proper depth for the box to facilitate fish passage was unknown at the time of design, but some additional depth below the bottom of the steppass exit was believed desirable. The filling of the box with bedload indicates that an extremely deep box would be of little value for similar installations which have considerable movement of bedload. However, the distribution of bedload flush with the bottom of the steppass has formed a normal gravel stream channel which shifts about within the box. This channel may be beneficial in that it is irregular enough to slow velocities and somewhat more natural feeling to the fish than a smooth cement slab with a sheet of water pouring across it.

Fishpass installation during low flow. Note bedload material in the ladder box.

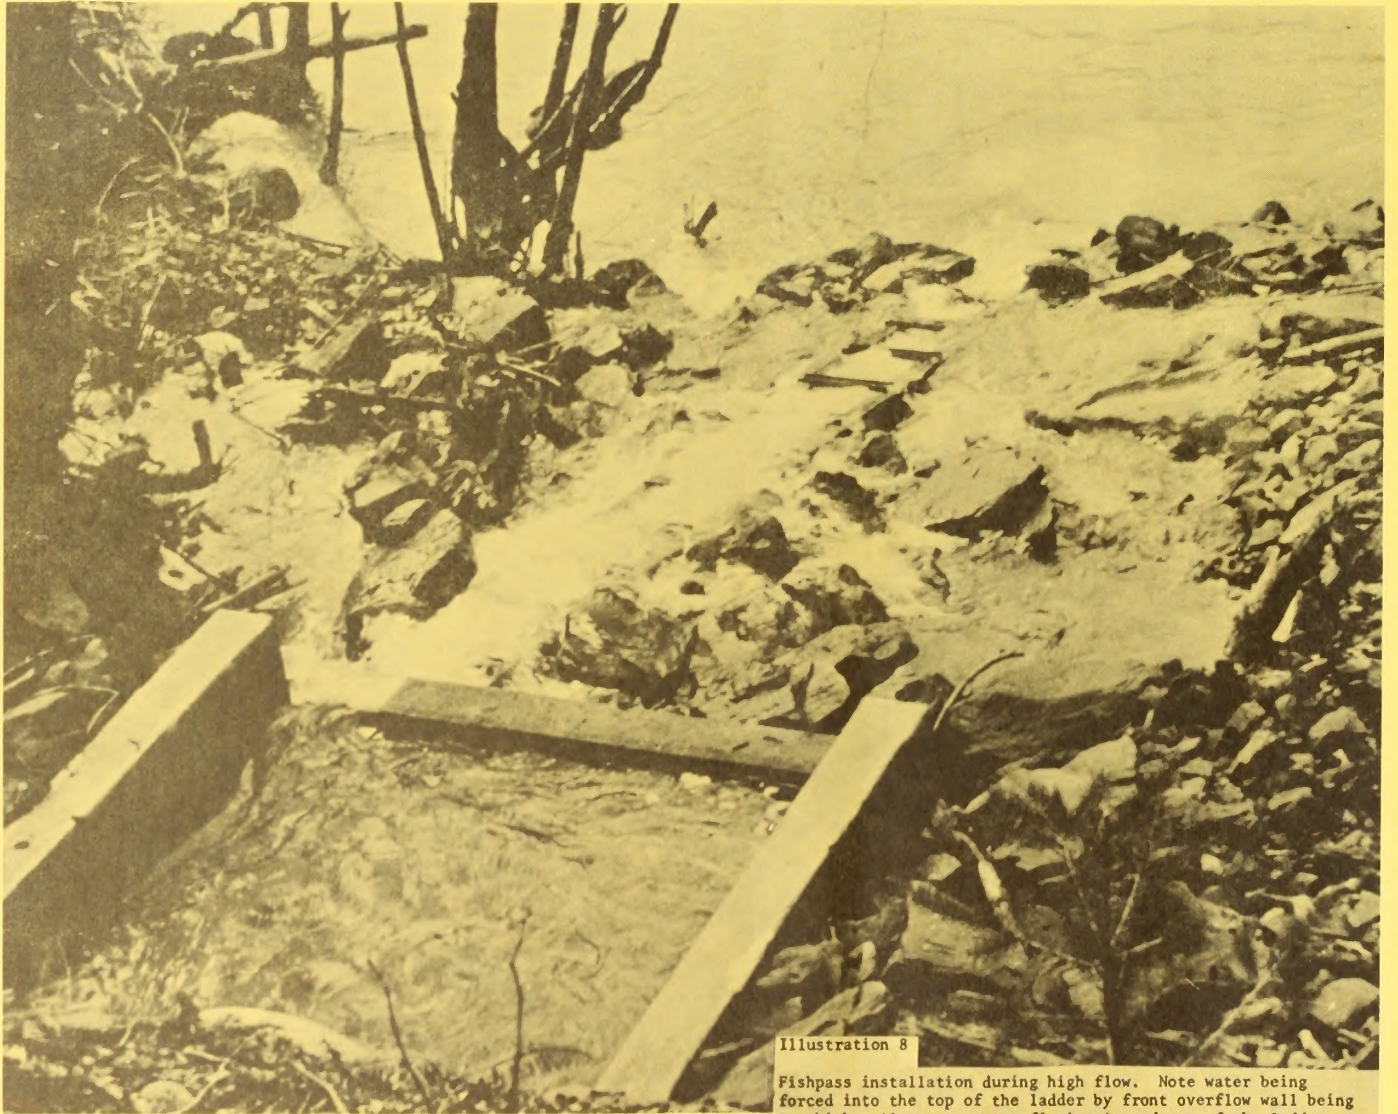
Illustration 8

The major problem with the installation occurred when a large amount of water moved bedload material out of the culvert. Numerous waterlogged pieces of wood and limbs had collected over many years in the culvert which had been partially blocked at the mouth. These chunks clogged the baffle fins of the fishpass. This problem was compounded by two factors. The front of the ladder box was built 8" higher than originally planned which forced most extra flow into the ladder slot instead of allowing it to spill evenly across the box front (See Illustrations 7 and 8).

The riprap was placed in such a manner that excess water was channeled into the top of the open steppass (Illustration 8). The extremely high flows then washed volleyball-sized riprap into the steppass where they were held in place by the previously mentioned wooden chunks. (The original design for the riprap called for a contouring that would channel excess water away from the steppass.)

Fishpass installation during high flow. Note water being forced into the top of the ladder by front overflow wall being too high. Also note water flowing in and out of the ladder as it moves down the ladder, due to improper contouring of riprap.

The blockage of the steppass was cleaned out in less than an hour by hand. Since the ladder was cleaned, only minor maintenance has been necessary. The facility remains completely clear most of the time and observation has indicated that fish were able to negotiate the steppass when it was heavily clogged with debris. Clogging, although a problem initially, does not appear to be a major problem in that the area has stabilized following the initial flushing. Minor bedload material, such as sand, gravel and stones up to 6" in diameter roll through without stopping and have been no problem.
